K M LIECHTI ET AL. SEP. 82 AFWAL-TR-82-4085

SEM/TEM FRACTOGRAPHY OF COMPOSITE MATERIALS

General Dynamics
Fort Worth Division
P.O. Box 748
Fort Worth, Texas 76101

SEPTEMBER 1982

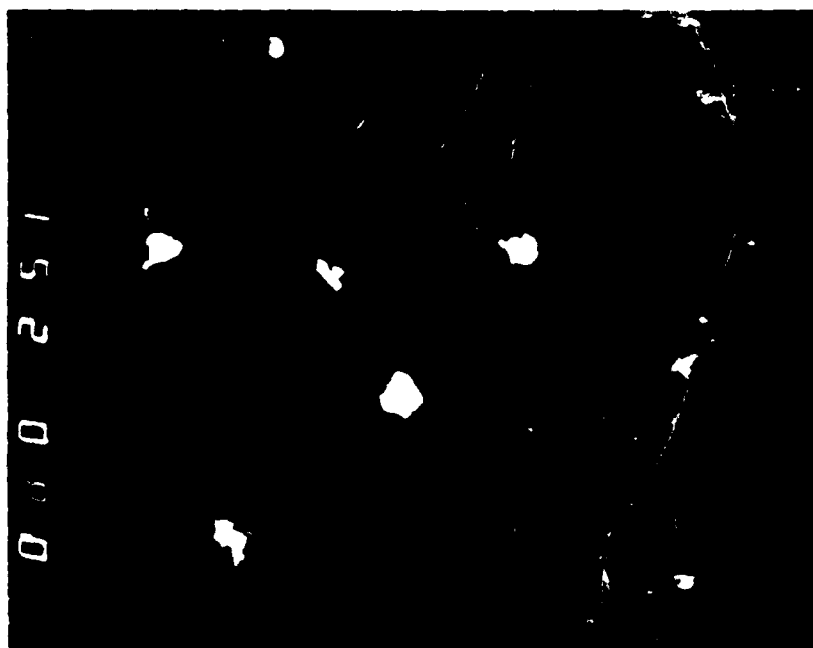
Figure 14 River Pattern in Resin Pocket in Mode I Specimen , 1500X

River patterns are evident at magnifications of 500X or higher in the resin material between fibers and in resin-rich regions (i.e., resin pockets which form when plies are butted together or at flaws in prepreg tape). The proposed explanation for their formation is that separate cleavage crack segments develop on parallel planes within the matrix regions. As the segments run through the resin, they grow in width and approach each other. Eventually, the crack segments join together fracturing thin ligaments of material and forming steps between the parallel cleavage planes. These steps converge in the direction of local crack propagation. Figures 14 and 15 illustrate typical river patterns found on Mode I type specimens. The pattern in Fig. 14 developed at a resin-rich region within the lamina while the pattern in Fig. 15 illustrates the cleavage of matrix material between fibers.

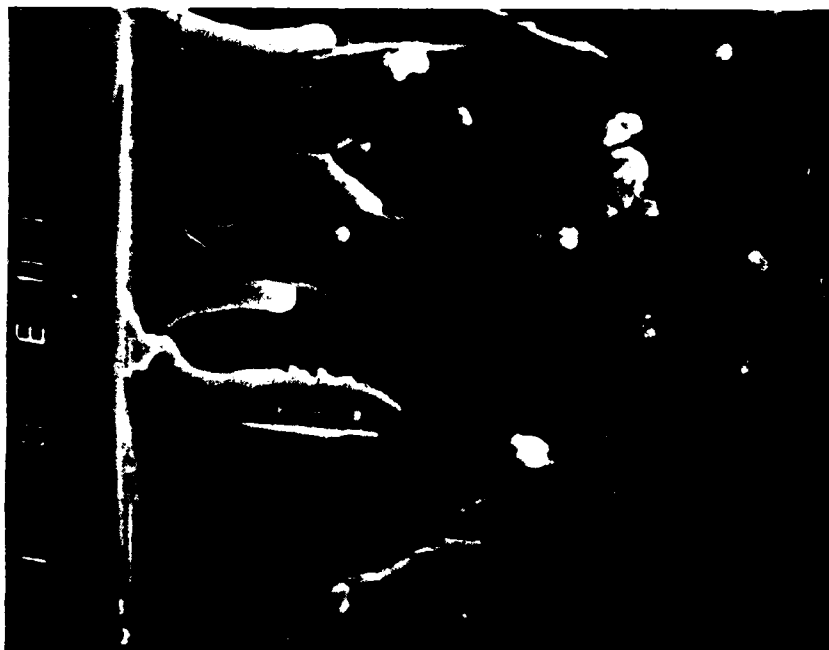
Figure 16 Photomicrograph of Feather Pattern on Mode I Specimen , 10,000X

Another distinct cleavage-fracture feature, the feather pattern or feather mark, was also evident in the failed matrix material. Compared to river patterns, feather marks are more difficult to detect; they have a finer texture and are seen at 3000X or more. They are chevron shaped surface marks which point back in the direction of local crack origin. Figure 16 is a 10000X photomicrograph of the surface of a Mode I specimen in which both river patterns and feather patterns are evident. Complex feather patterns were also found on Mode II specimens. Figure 17 is an example of such a pattern.

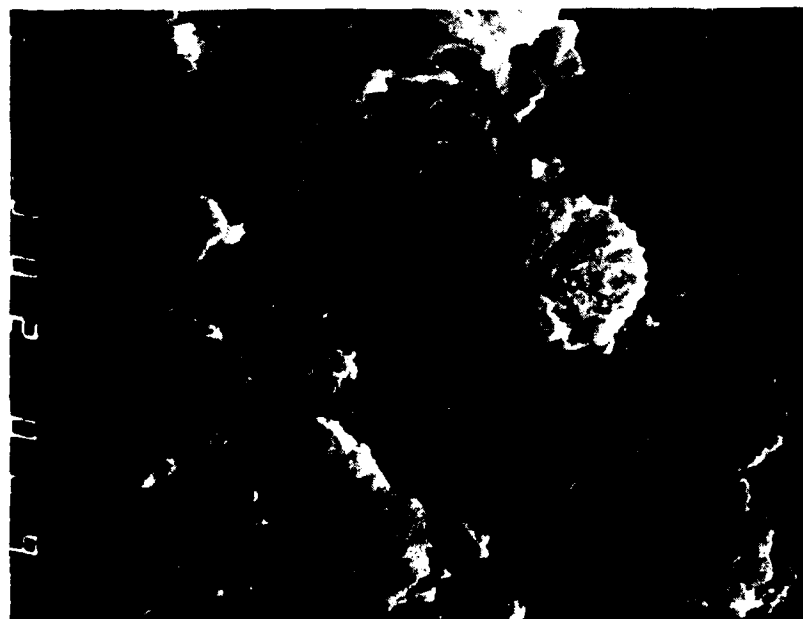
Figure 18 Typical Fiber Fracture Surfaces, 3000X

Figure 18 illustrates typical fiber fracture surfaces. These features were observed in a 0° tensile specimen. As the figure shows, origins and direction of a crack through an individual fiber are detectable by the radial striations imprinted on the fractured fiber surface. Most fiber fractures originate at the fiber's periphery, but some were found to initiate at internal flaws. In many instances, the fracture of two or three fibers may be traced to a common origin at an interfacial point between the fibers. However, an inspection of the whole specimen surface reveals that no global crack propagation direction can be associated with these radial striations as they appear to be randomly oriented.

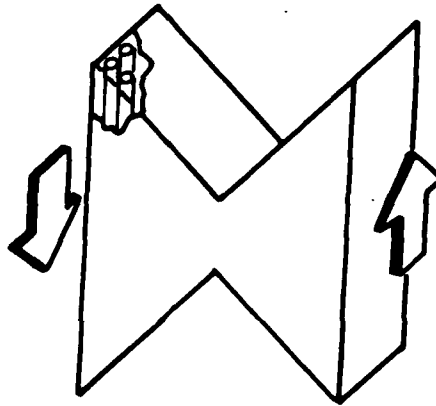
Figure 19a Macroscopic Views of Typical G_{12} Shear Specimen , 5X and 14X

Figure 19 consists of macroscopic and microscopic views of the fracture surface of a typical G_{12} shear specimen. The test conditions, failure stress and the primary fractography characteristics are itemized on the figure data sheet. A macroscopic view of a typical failed specimen is shown in Fig. 19a. A 5X photograph of the specimen which has been removed from its aluminum loading rings demonstrates that the failure surfaces were planar on a macroscopic scale. Specimen damage was confined to the

failure site. Fig. 19a also has a 14X macroscopic photograph of the two failed surfaces. Again the surfaces appear planar, but local regions of fiber pullout are evident, giving the surfaces a rough or "rutted" appearance.

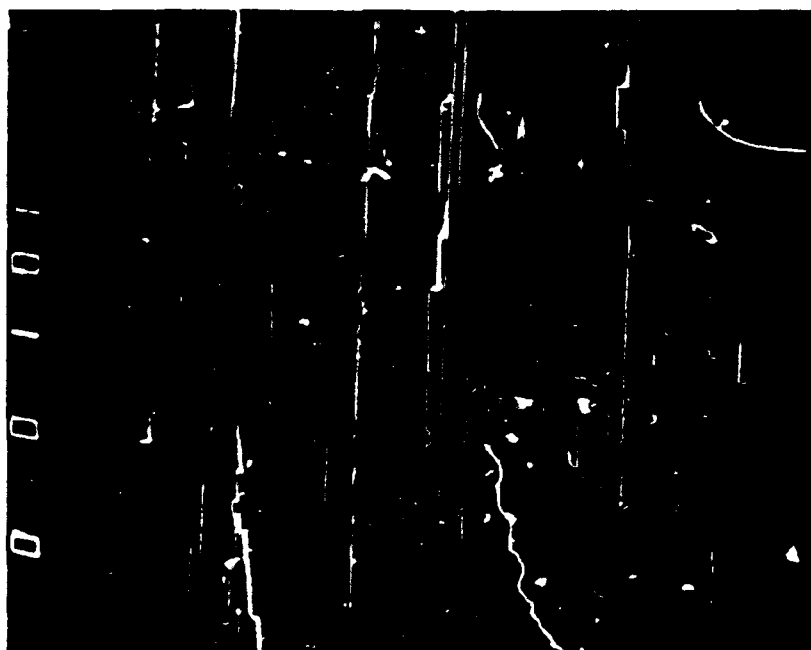
Figure 21c Photomicrograph of G₂₃ Shear Specimen Surface, 100x

The G₂₃ specimens also differed from the G₁₂ and G₃₁ specimens on the microscopic level. Investigation showed that none of the characteristic hackle features developed on the specimens. Instead, matrix artifacts consisted of cleavage features (i.e., river patterns). Figure 21c is a 100X photomicrograph of a typical specimen section. Several cavities which once contained fibers are evident on the specimen surface. The resin material which surrounds these voids appears to be relatively undisturbed. (This observation is verified in Fig. 21d). The bright curved feature which appears in the upper right corner of the photograph is a sliver of matrix material which has been partially stripped away from the adjacent fiber. These stringers were found throughout the failed surface. Figure 21d is a micrograph of that same stringer. The figure also demonstrates the development of river patterns in the matrix material between fibers. These cleavage features were also evident throughout the specimen. The river patterns and the position of the matrix stringer indicate that, at least locally, the crack front progressed from left to right.

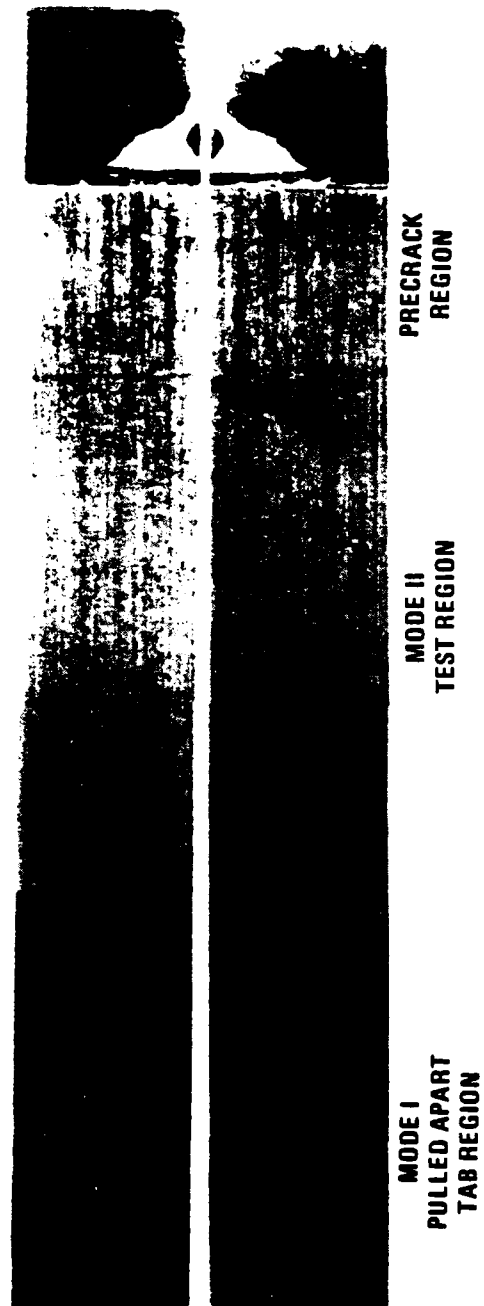
Figure 23a Macroscopic View of Mode II Fracture Surface, 1x

Figure	Characteristic
a	Mode I (left) and Mode II (right) Fracture Surfaces on a Mode II Coupon (macroscopic)
b	Fracture Surface
c, e	Hackle Patterns
d	Feather Patterns

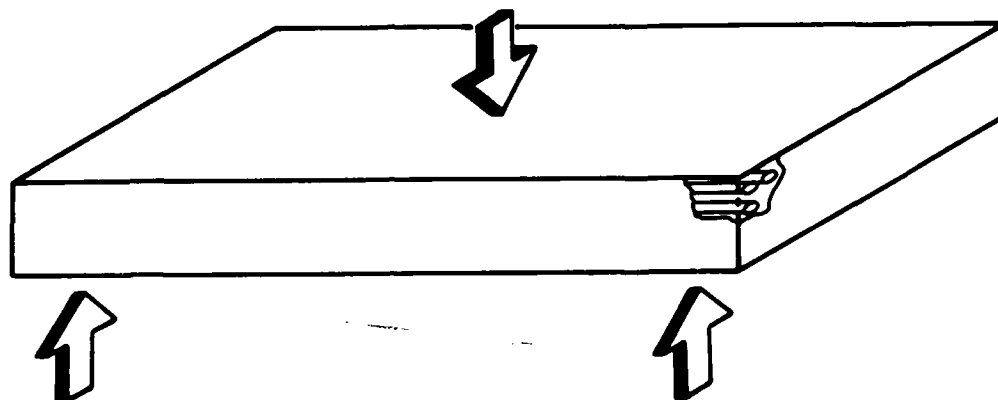
Specimen:	19B3-C (roll 19B)
Stress State	σ_{11}, τ_{13} (complex)
Ultimate Stress	*
Average (of 9)	
Ultimate Stress	168.2 ksi
Material:	AS1/3502
Test Rate	0.05 in/min
Environment	Ambient
Initial Defects	None
Failure Sequence	Fiber failure of bottom ply (Maximum Tensile Stress) followed by multiple ply delamination due to shearing stresses.

Figure	Characteristic
a	Fracture Mode (macroscopic)
b,c	Fiber Spines
d,e	Hackles on Delaminated Surface

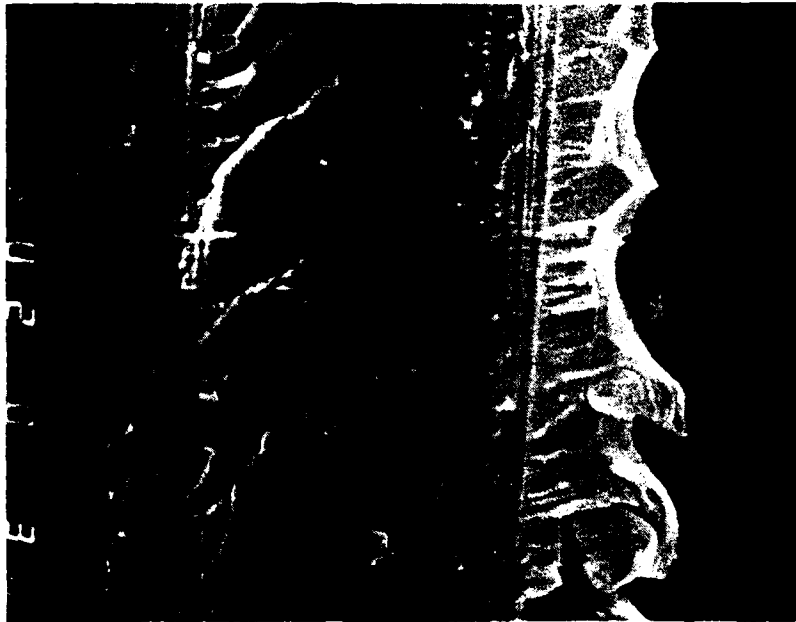
Figure 30e River Markings on Debris Free of Apex Feature , 5000X

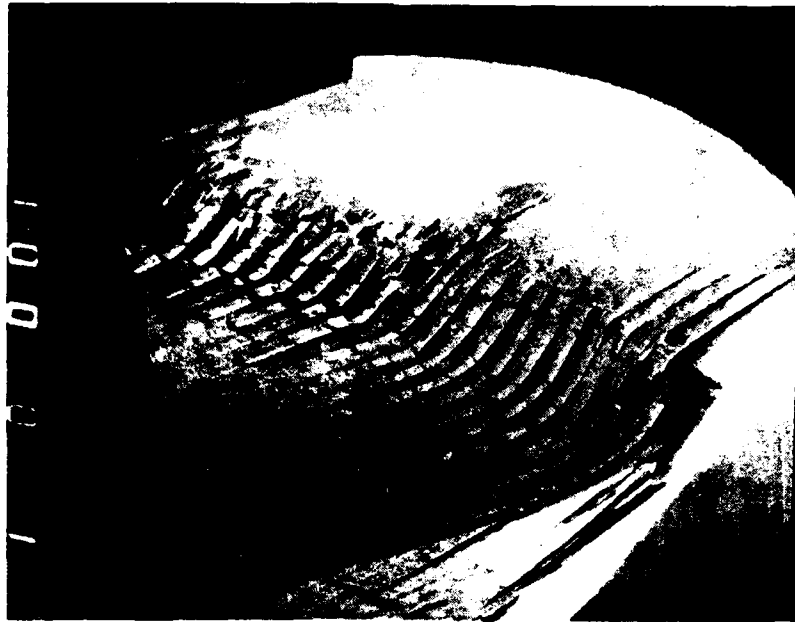
Figure 31c Kinking, Slip & Delaminations in $\pm 45^\circ$ Specimens in Compression, 10X

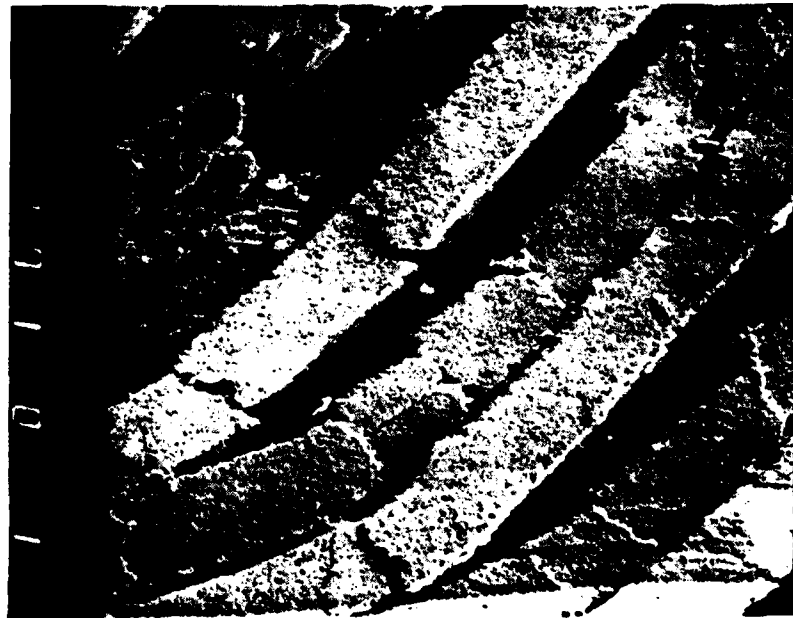
Figure 31d Higher Magnification of Kinking, Slip & Delaminations in $\pm 45^\circ$ Specimens in Compression, 100X

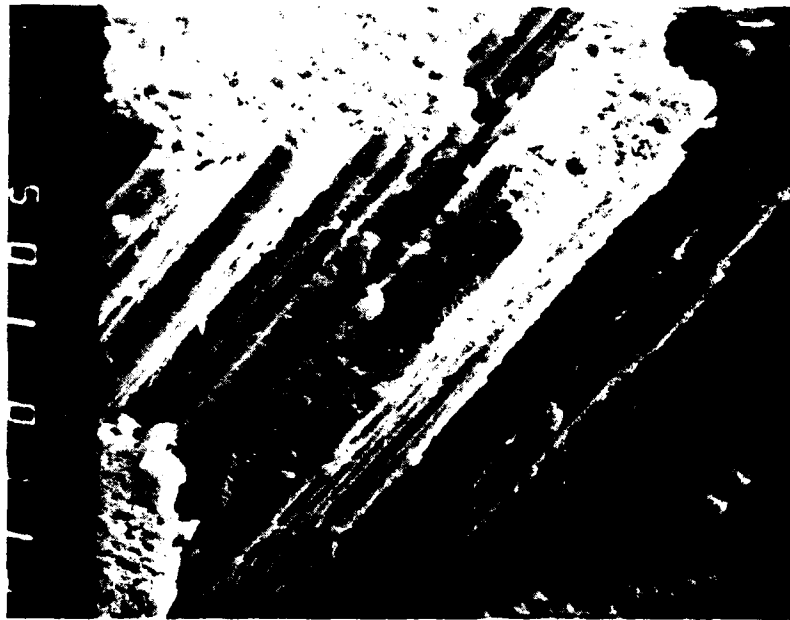
Figure 31e Unbroken Fibers in $\pm 45^\circ$ Specimens in Compression, 500X

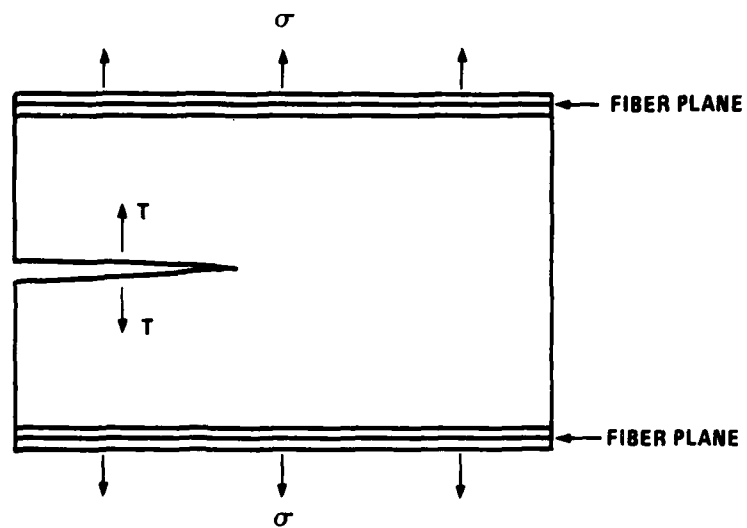
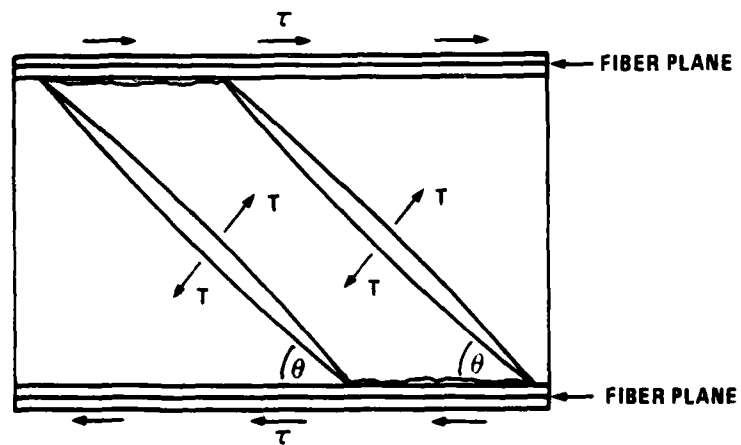
Figure 34 Schematic of Formation of Cleavage and Hackle Features

The fracture plane in any loading condition in a brittle material is perpendicular to the maximum resolved tensile direction (Fig. 34a). When the fibers lie perpendicular to

the maximum tensile direction, a single cleavage plane parallel to the fibers results. The features of river and feather patterns fall into this category. However, when the fibers are not perpendicular to the maximum tensile direction, e.g., in a situation where shear is locally predominant, the fracture plane intersects the plane of the fibers. The fiber planes generally restrict any further growth of the crack with the result that a series of parallel fissures occur in the region between the fiber planes (Fig. 34b). Such conditions give rise to the hackle feature, which has also been observed in the analogous situation of a metal-to-metal adhesively bonded joint loaded in shear. The occurrence of all three features on some occasions indicates that the local stress state should be considered in conjunction with the globally applied loading in the inspection of any failure surface.
